Technical Bulletin

METAL BUILDING SYSTEMS

Wind Design and Performance

W. Lee Shoemaker, P.E., Ph.D.
Director of Research and Engineering

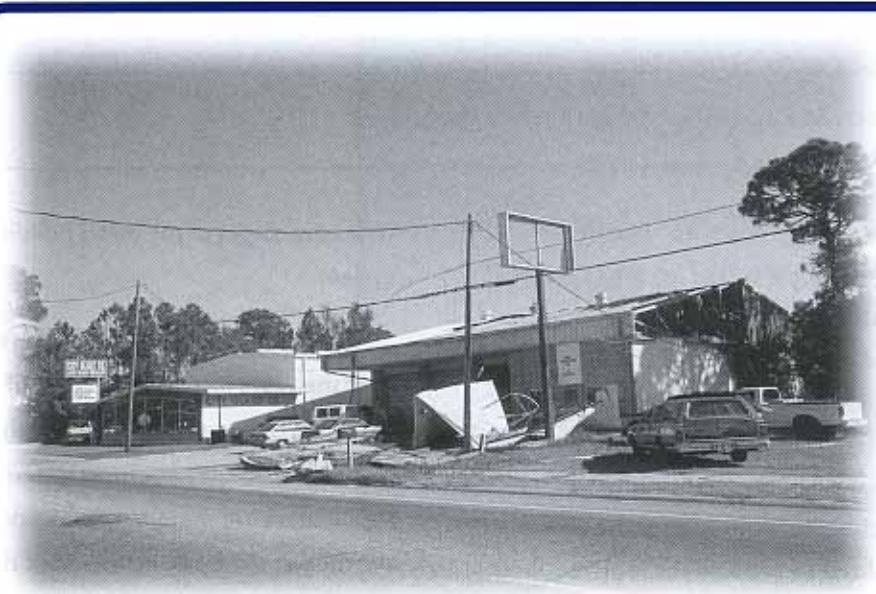
Photo 1: Hurricane Opal Observation – Engineered metal building system on left, multi-component building with wood trusses, metal cladding/roofing on right.

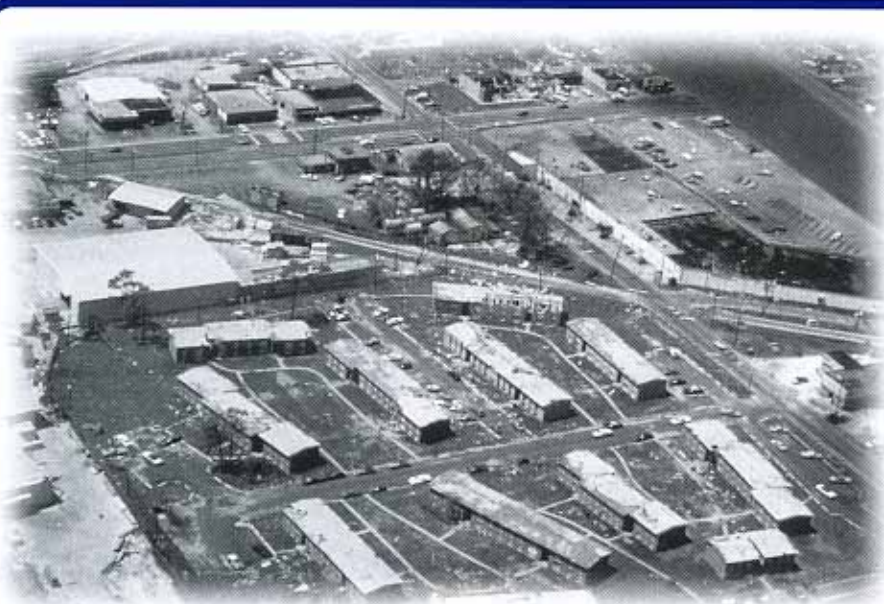
hurricanes Alicia, or possibly Elena, may not be a predictor of performance of buildings designed to today's codes (See Photo 3).

Photo 3: Hurricane Elena Observation – Large cross-section of metal buildings and metal roofs designed to various codes due to their apparent age. Newer buildings show little or no damage.

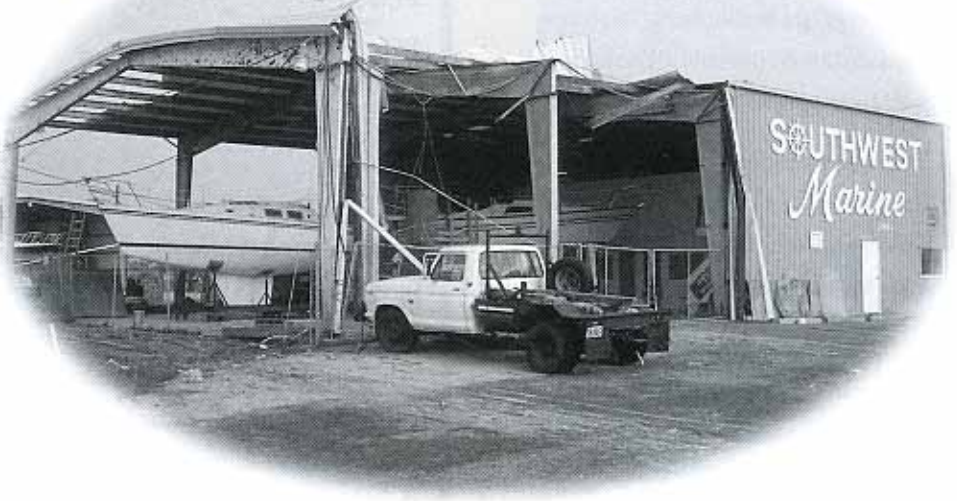
- 1) *Roof damage caused by overhead door failures.*
- 2) *Roof and wall damage in buildings which had some open bays (See Photo 4).*
- 3) *Damage due to interface between metal buildings and masonry walls."*

Photo 4: Hurricane Alicia Observation – Roof and wall damage to building with some open bays.

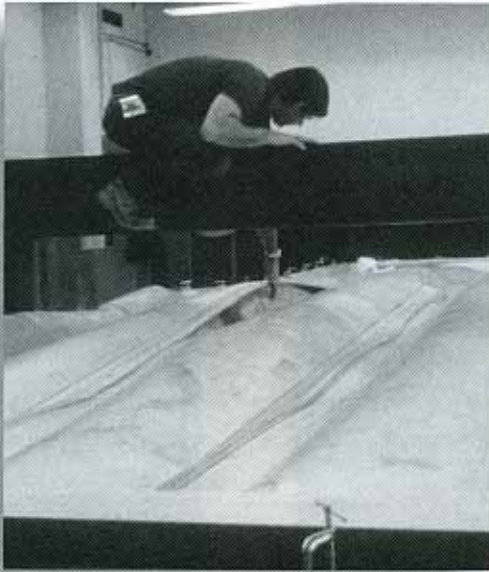
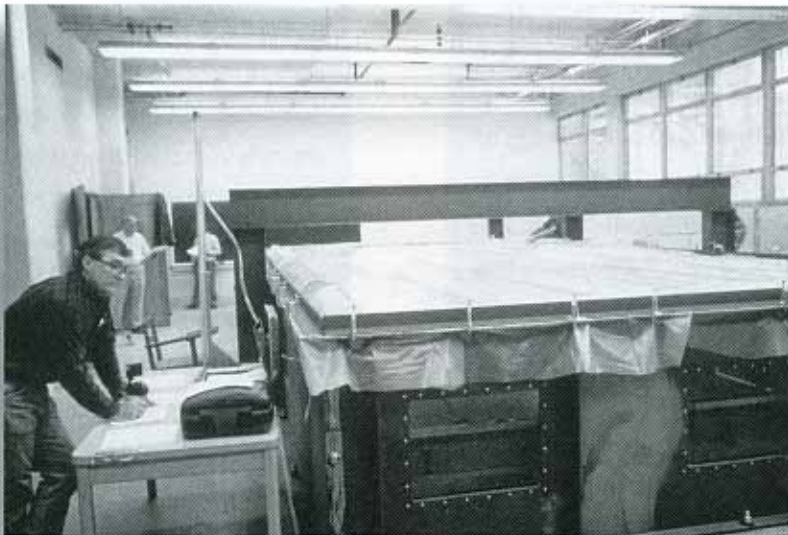
capacity be based on the ASTM E1592 test method.” In fact, this has been the direction of the industry over the last few years. ASTM E1592 provides a test that reduces the boundary condition effects and provides a better indication of the structural capacity of standing seam roofs (See Photo 5).

Photo 5: ASTM E1592 test of a standing seam roof to determine uplift capacity.

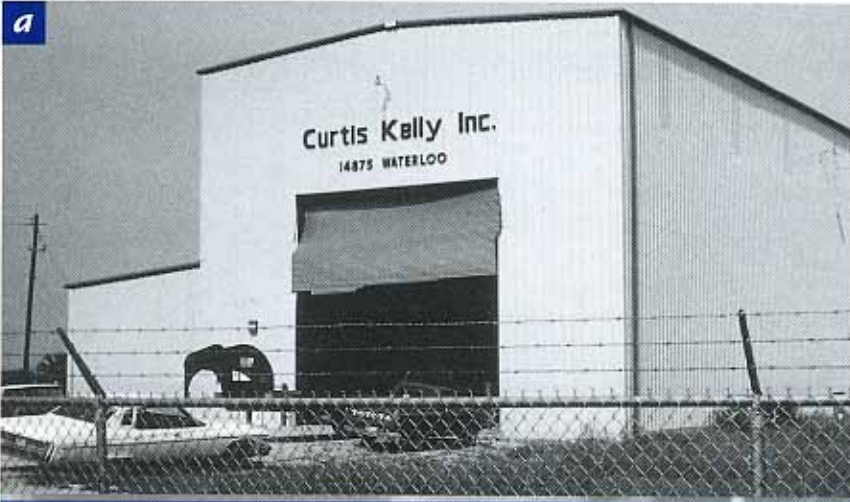
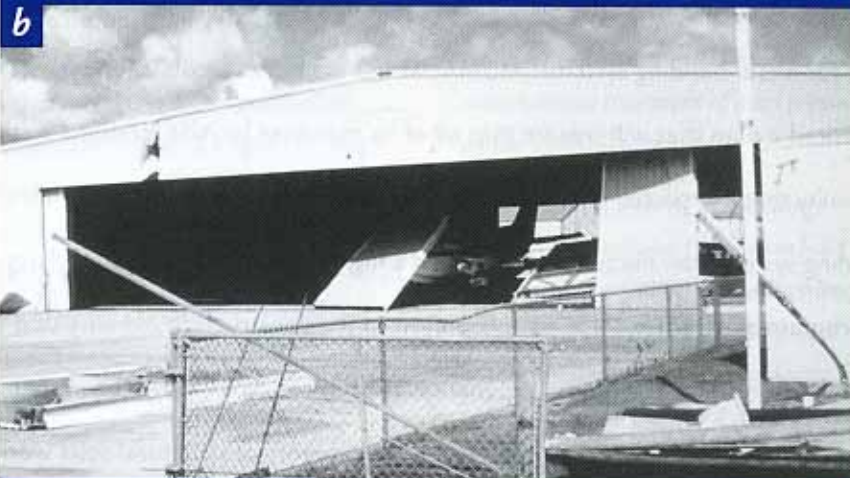
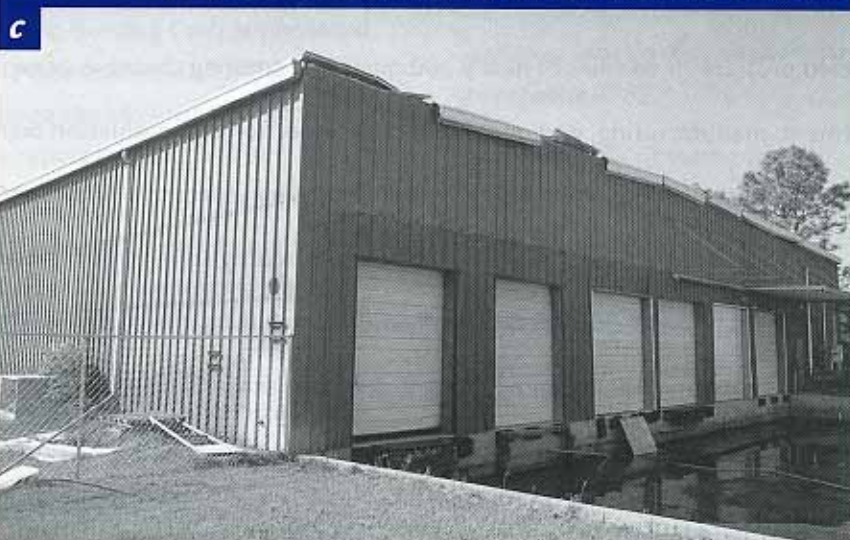
Photo 6: Observed damage to overhead doors a) Hurricane Alicia b) Hurricane Elena c) Hurricane Opal

Note that the building designed to more recent code in Opal only suffered damage to canopy and edge flashing.

A common observation in many of the hurricane investigations was that large doors blew in and may have caused increased internal pressure that resulted in roof and wall failures (See Photo 6). Large doors are not supplied by the metal building manufacturer, but are either selected by the builder or design professional for the project. This creates the potential for miscommunication or the selection of an incompatible door that does not have the same strength as the rest of the building envelope. Most metal building manufacturers stipulate in their letter of certification that they have assumed in their building design that the doors will support the same wind loads that the door jambs and support structure have been designed for. Some manufacturers have gone further and require a signed letter

back from the responsible party for the doors in the order confirmation that stipulates that the proper doors have been selected that are compatible with the design assumption that the building is enclosed.
