CASE STUDY

# ROOFING & SOLAR

## EXCELLENCE IN ROOFING SYSTEMS & SOLAR PANELS

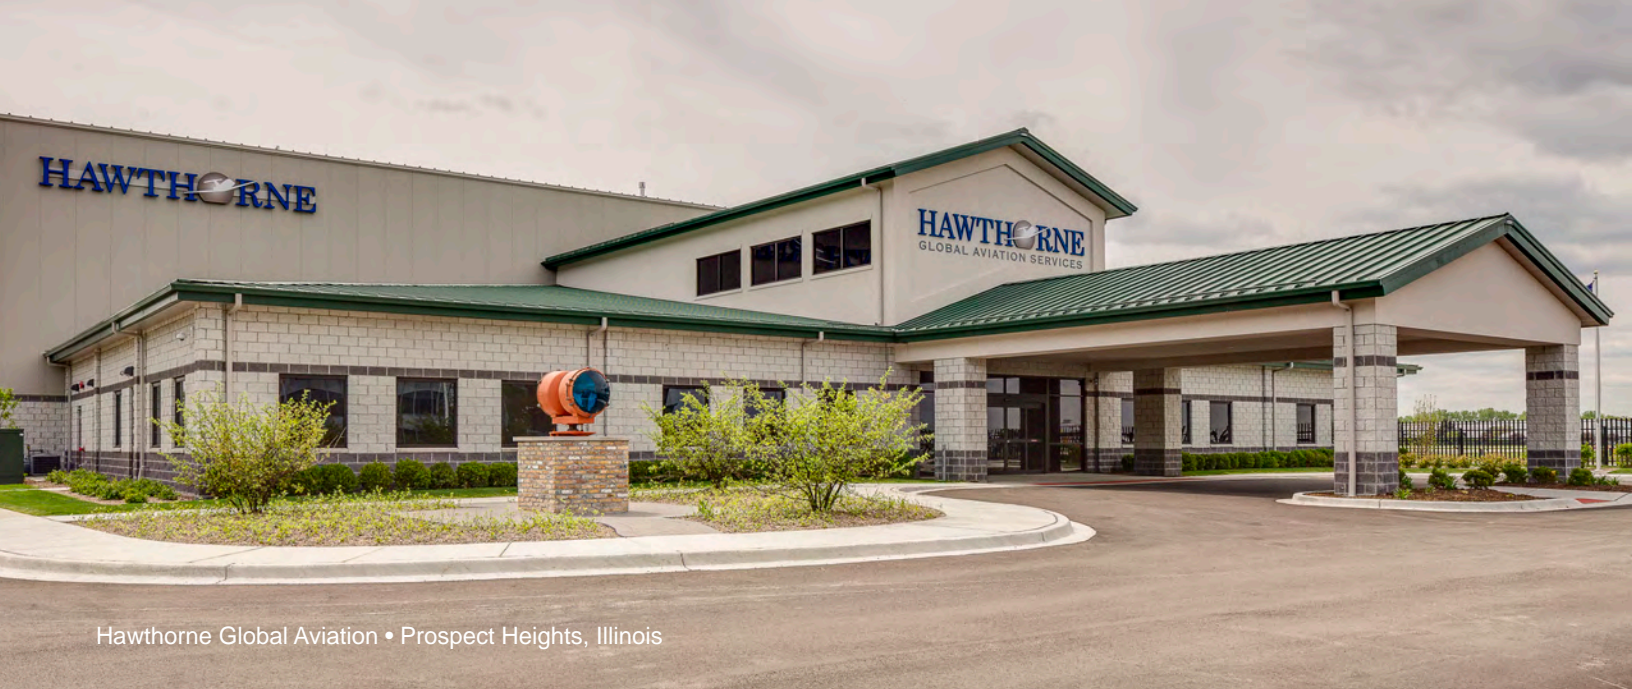
Hawthorne Global Aviation • Prospect Heights, Illinois

Hawthorne Chicago Executive Airport's 30,000-sq.-ft. hangar accommodates a wide range of aircraft, with a 28-ft. by 160-ft. door. The bright and airy facility provides luxury amenities for executive travelers, including a conference room to accommodate 10 people, workstations, and an executive lounge. The metal building was chosen to offer architectural integrity. The standing seam roof, with a cool roof coating that includes R-30 installation, helped the airport developers achieve their aesthetic and environmental goals. Located in the Chicago, Illinois suburb of Prospect Heights, the metal roof withstands significant snow loads and the harsh, beating winds common to cities on the shoreline of Lake Michigan.

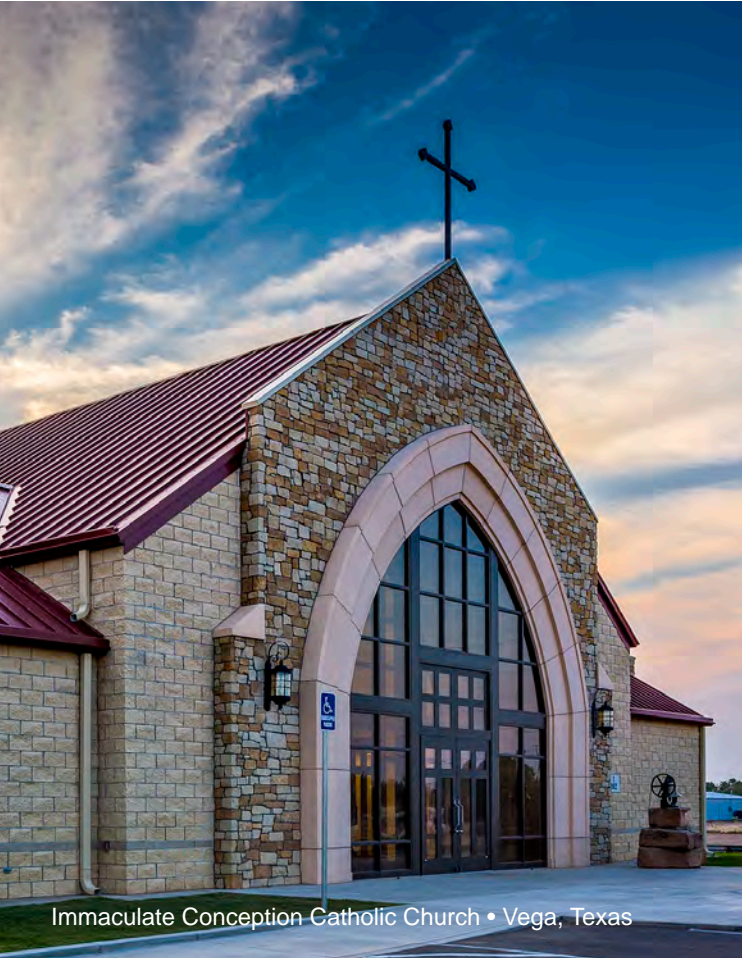
Immaculate Conception Catholic Church • Vega, Texas

Vega, Texas is a small farming community in the panhandle of Texas, with its nearest big city, Amarillo, 40 miles away. The Catholic community in this town of less than 1,000 people needed an attractive new church—one the parishioners' budget could handle. The solution was a metal building system with an attractive brick exterior, topped with a standing seam metal roof. The roof, rated to 140-mile per hour winds, was a logical solution to withstand west Texas' harsh climate.

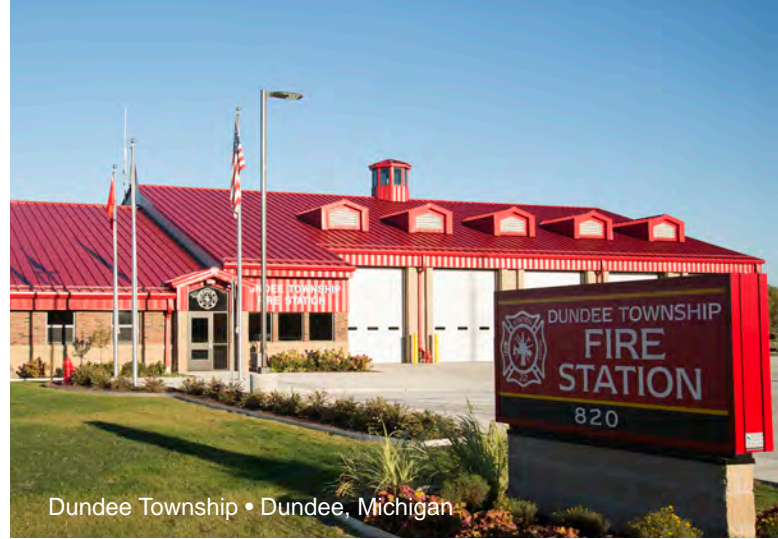
Dundee Township • Dundee, Michigan

In the southeast corner of Michigan, Dundee Township is home to just under 4,000 people. Though small, the community funded a fire station that was not only cost-effective but provided a strong architectural statement. The clearspan, open interior 8,250-sq.-ft. equipment bay provides for vehicle storage and includes a 1,280-sq.-ft. mezzanine. An additional 5,400 sq. ft. provides for offices, a conference room, a kitchen and pantry, and housing for firefighters. The design offers an attractive roof height elevation change, dormers, and cupola—all capped with a bright red metal roof to match the life-saving rescue equipment housed inside.

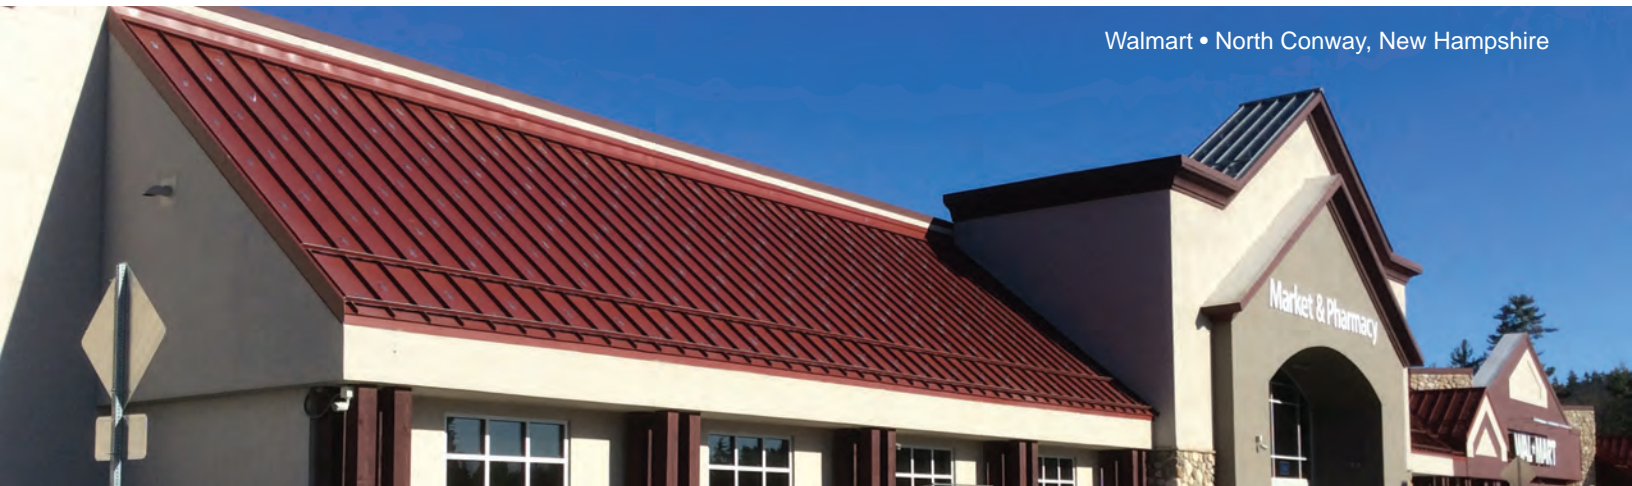
Walmart • North Conway, New Hampshire

An average annual snowfall of 80 inches created problems at the Walmart in North Conway, New Hampshire. Dangerous snow slides occurred, requiring closure on areas around the front entrance to assure the safety of patrons and employees. Walmart's Construction Management group, in coordination with BRR Architecture of Bentonville, Arkansas, and general contractor, Bast Hatfield of Clifton Park, New York contacted metal roof contracting specialist Jottan-Jorel of Evans City, Pennsylvania. Jottan-Jorel completed installation of a high-quality snow retention system onto the existing metal roof in a matter of days that is guaranteed to perform for the life of the roof.

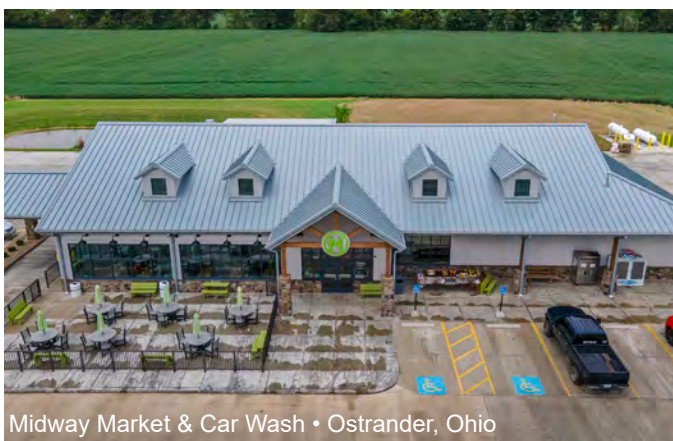
Midway Market & Car Wash • Ostrander, Ohio

This convenience store, car wash and Shell gas station in Ostrander, Ohio, is a prime example of how form and function blend beautifully within a metal building system. Here, one of the highlights is the detail in and around the roof area. Dormers, gables, soffits, canopies and a clearstory element accentuate the drama of the expansive and distinctive metal roof. The dormer details were particularly difficult, but working with the metal building manufacturer, the contractors were able to assure a leak-tight fit for this complicated construction challenge.

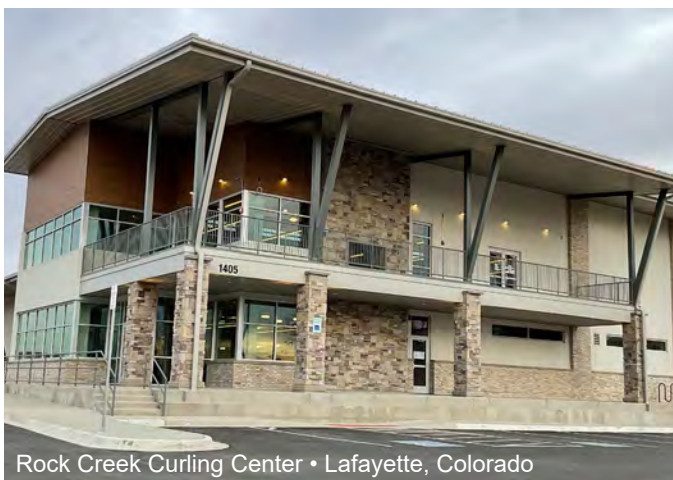
Rock Creek Curling Center • Lafayette, Colorado

Calcon Constructors built this two-story, 32,598-square-foot curling center in Lafayette, Colorado, which features an inventive roof layout that accentuates the building's powerful design objective. Envisioned by the architectural team at Farnsworth Group, Inc., the building highlights include a curling rink, a two-story viewing area, an outdoor patio, a pro shop, a kitchen and a bar, indoor/outdoor fireplaces, and lockers and restrooms. As often happens with metal building technology, the contractors were able to expedite construction, adhering to a brief 13-month completion schedule.

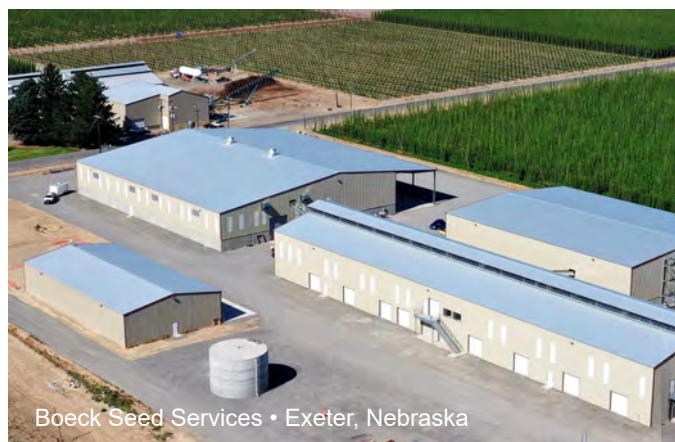
Boeck Seed Services • Exeter, Nebraska

In Exeter, Nebraska, Schwisow Construction brought new life to Boeck Seed Services' facility by expanding it substantially and providing complex renovations. With the help of Davis Design, the construction team completed an addition to an existing metal building, enhancing the work environment by adding high-end interior finishes. Selective removal of the existing metal building wall system allowed seamless expansion into the existing office.

For the exterior, roof extensions, canopy overhangs, soffits and roof height changes were required to accommodate the upgraded design. This included 80 feet of roof height increase from the lower office addition to the higher common shop wall. Also, due to the 3:12 roof pitch, clearance at the low eave—where the main entrance is located—required special coordination.

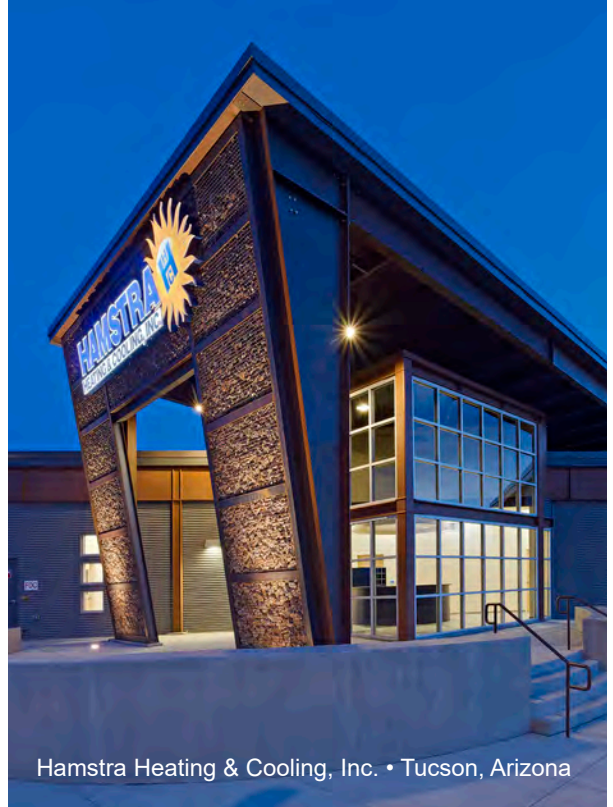
Hamstra Heating & Cooling, Inc. • Tucson, Arizona

Heating and cooling need not be boring. This statement is underscored in the beauty of this Tucson, Arizona structure. Separated into office and display areas, as well as warehousing, the building features a faux rust finish installed vertically on girts, with end walls installed horizontally on inset studs. The canopy is a metal standing seam roof, also with a faux rust finish. The structure is connected to a rainwater harvesting system that incorporates a tank and storage tower.

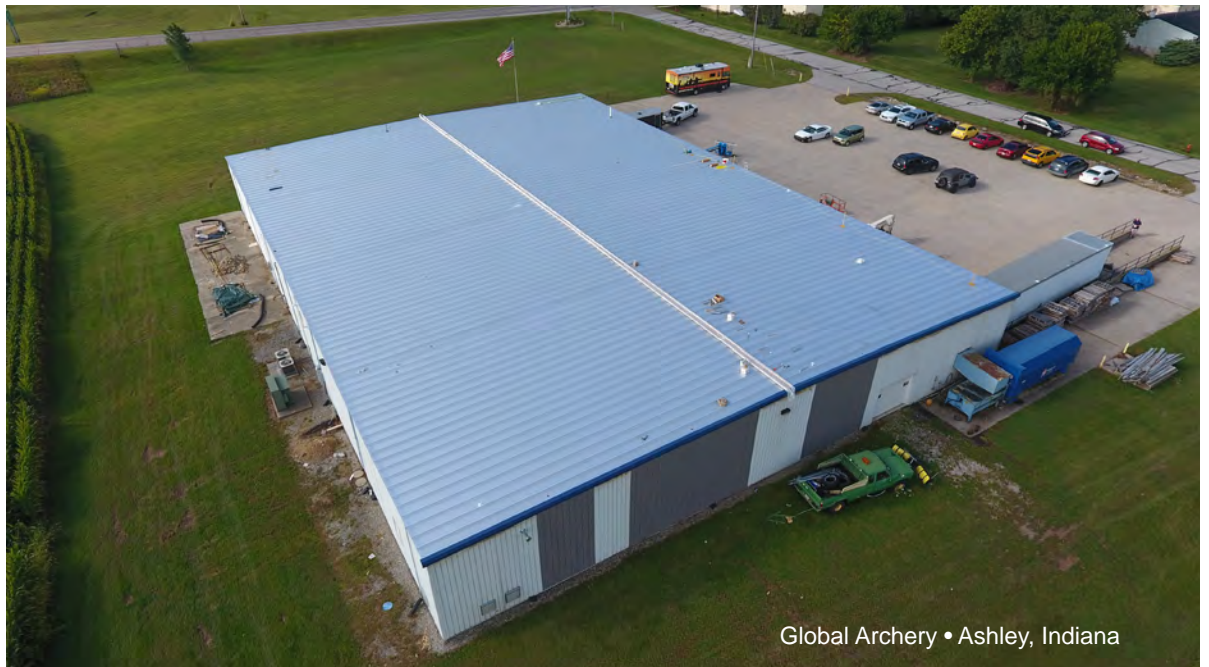
Global Archery • Ashley, Indiana

Global Archery is headquartered in a 1980s-era metal building in Ashley, Indiana. With over 40 years of useful service, this facility's metal roof was in need of replacement. The solution was to place a new metal surface over the existing one. The re-roofing of more than 20,000 sq. ft. was accomplished using structural factory-notched sub-purlins and a 24-gauge, 180-degree roof panel system. The 4.5-inch height of the vintage roof allowed for 6 inches of unfaced fiberglass insulation to be installed between the old roof and the underside of the new one, adding energy efficiency to the facility. The metal-over-metal roofing provides a solution to serve the facility for decades to come.

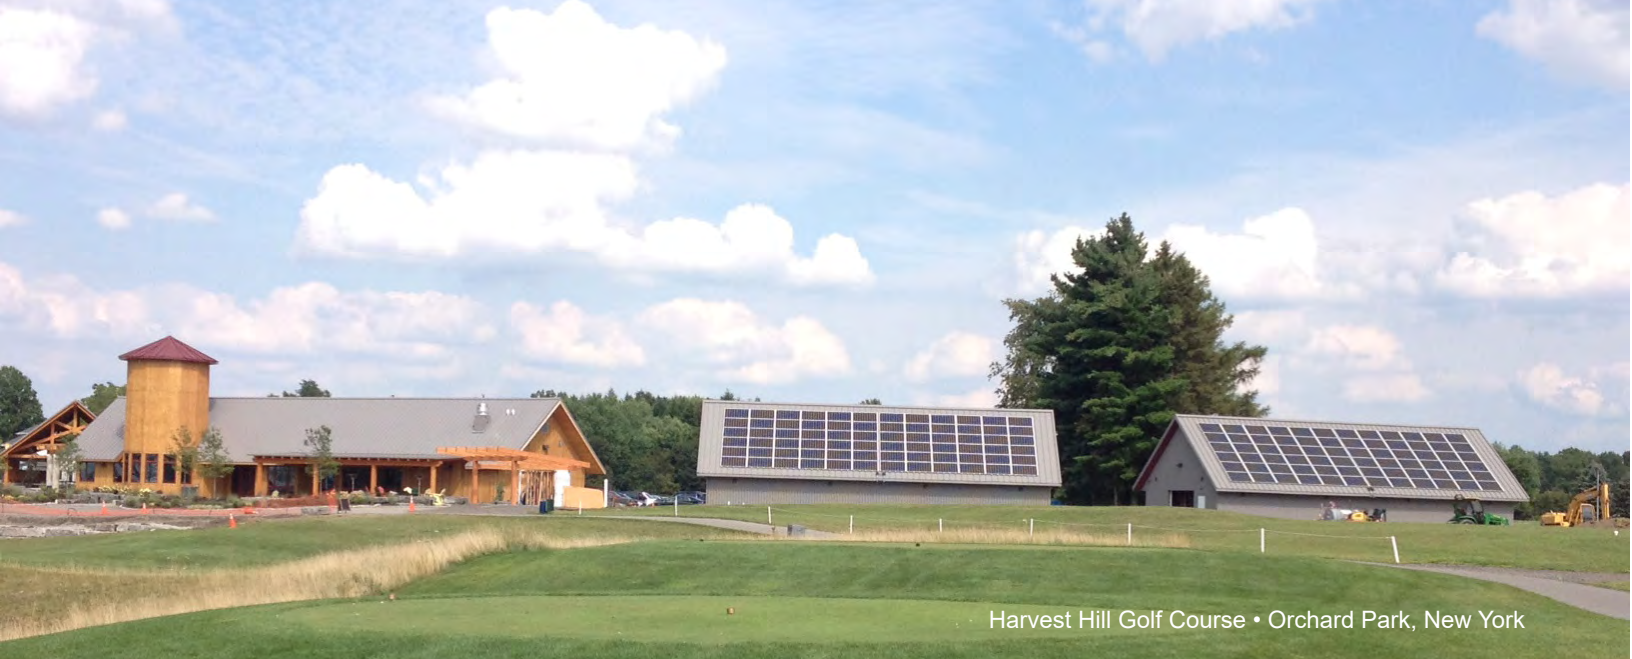
Harvest Hill Golf Course • Orchard Park, New York

Harvest Hill Golf Course in Orchard Park, New York is a world-class, 18-hole facility. It was expanded to include a new clubhouse, two cart houses, and a tournament pavilion. Upon completion, the Harvest Hill staff contracted Frey Electric to install a solar harvesting system for the cart house structures with the goal of partially offsetting energy costs. Because the steep slope allows snow to shed quickly from the PV modules mounted on a metal roof system, the energy output is higher than the originally projected values and is anticipated to provide 20% of Harvest Hill's annual power requirements.
